Factory-Built Grease Duct - 5 Years Later...

In January 2001, major renovations were completed at Texas A&M University's Sbisa Dining Hall, an 87-yearold building located on the north side of the university's campus. Sbisa Dining Hall served its first meal in 1913, and was originally designed to house the university's Corp. Cadets. It served as their meeting place for several years and was the largest building on campus at the time of its construction. The original wood framed structure has been in continuous use since it was built. Last remodeled in the 70's and showing deterioration, Texas A&M began to develop renovation plans in 1997. The plans included upgrading the existing kitchen ventilation system.

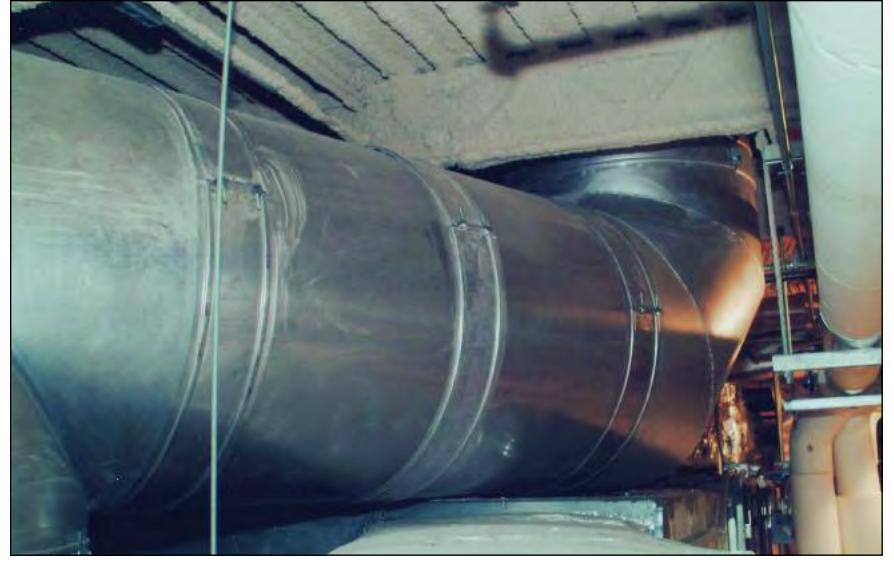
Metal-Fab Series 4G Grease Duct is leak-free.

The engineers specified Metal-Fab® Series 4G Grease Duct, a factory-built round duct with 4 inches of ceramic insulation enclosed in an integral steel chase. The duct is constructed of 304 stainless steel, is easier to maintain than rectangular carbon steel duct and is quieter. It is UL listed for zero clearance

to combustibles. The zero clearance listing eliminated the need for an additional chase to be constructed around the duct. This made it easier to install in tight spaces, especially within the new mechanical mezzanine where air handling equipment and HVAC ducting dominated the available space.

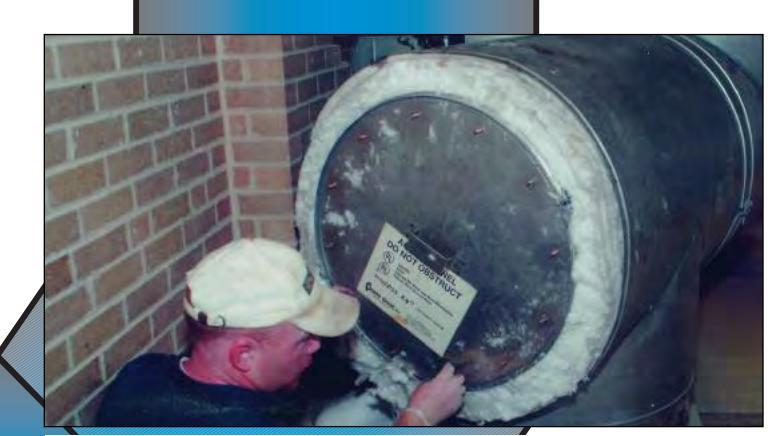
Quick access cleanout covers speed cleaning time.

The cleanout covers on the Metal-Fab 4G duct require no tools, so removal and replacing is fast and easy. Triple B foreman Justin Sullivan commented, "The covers with the wing nuts make it real easy."

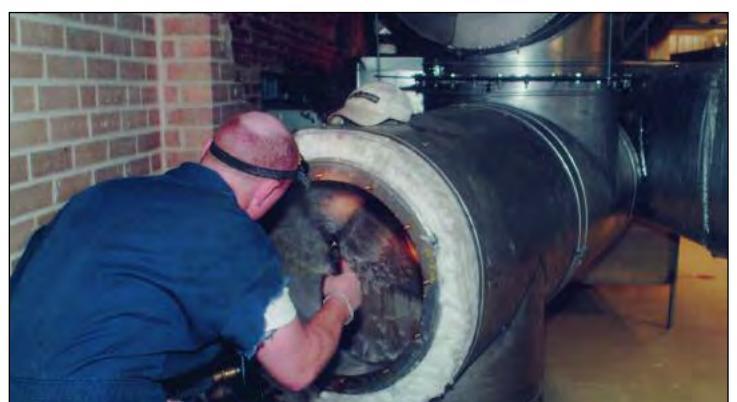
Cleaning process requires no brushing or scraping.

"It takes less than a day now, where it used to take about four days to clean the old black iron duct in Sbisa Dining Hall. Accessibility is easy and all we have to do is chemical spray and rinse, and there are no leaks in the duct. I also think the regular cleaning schedule makes cleaning easier," Kurt McCoslin, Triple B president stated.

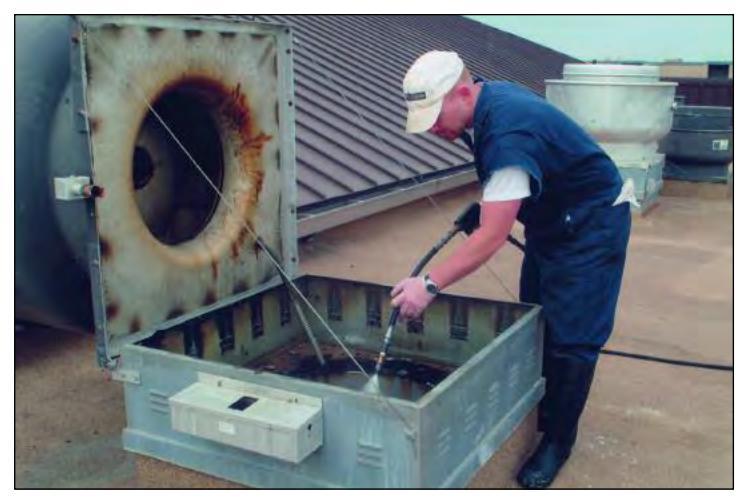
Spraying from roof down, no leaks below.

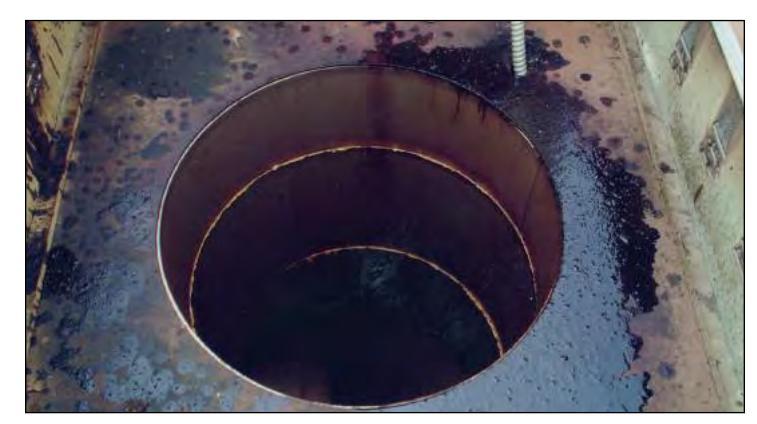
Before cleaning.

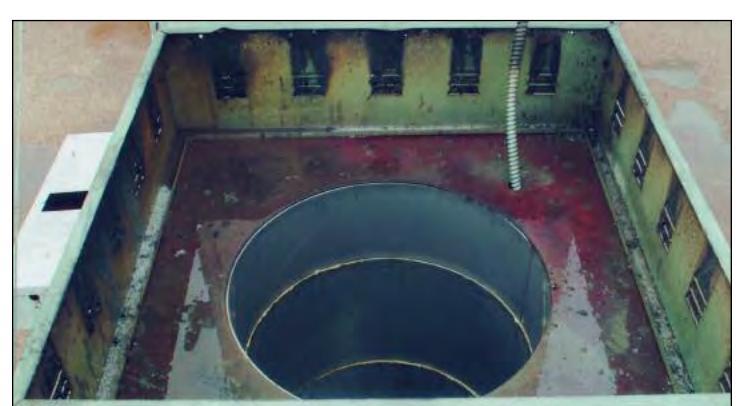
After cleaning.
