Commercial Venting CASE STUDY

Impossible Made Possible With Integral Chased Grease Duct

Factory-Built Grease Duct - 5 Years Later...

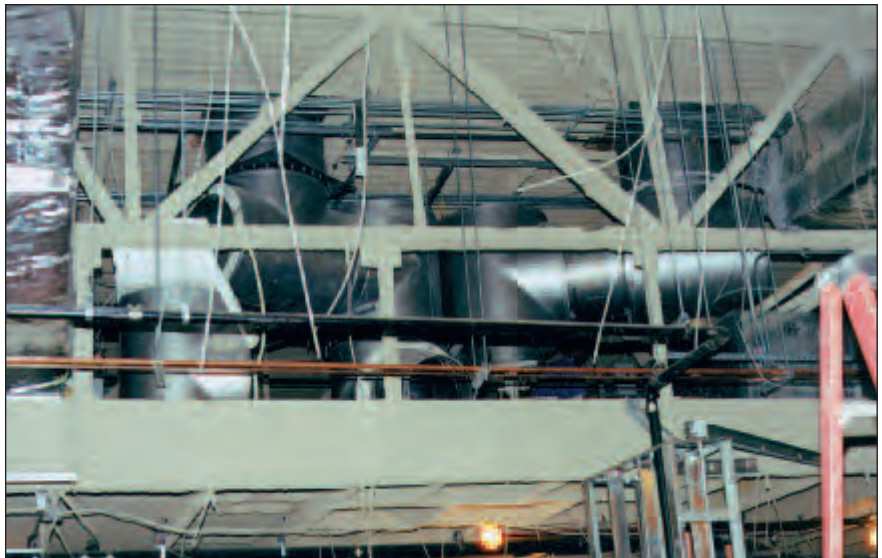
Space was tight, especially in the mechanical mezzanine above the original kitchen area.

through various levels of the structure would have to be constructed. We felt that required duct clearances to combustibles could not be reasonably maintained. In addition, concrete ceiling beams and floors were low. There were two ceilings above the kitchen. Ducting had to be worked around concrete pillars and other piping.”
